Demonstration of Load Rating Capabilities through Physical Load Testing: Ida County Bridge Case Study

Final Report 2 of 3
August 2013

Sponsored by
Soy Transportation Coalition
Federal Highway Administration
Iowa Department of Transportation
(Part of InTrans Project 12-444)

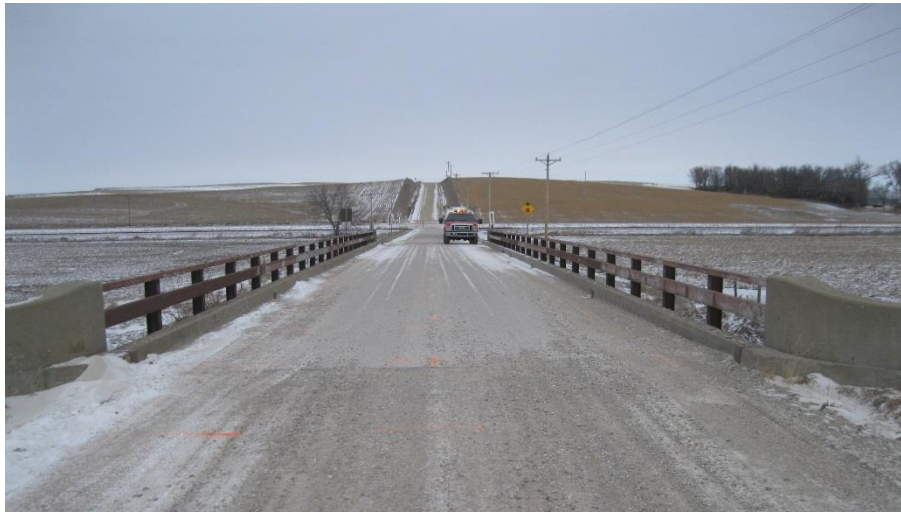
Figure 2. Two-lane Ida County Bridge end view

Figures 2 and 3 show end and elevation views, respectively, at the time of testing in 2013.

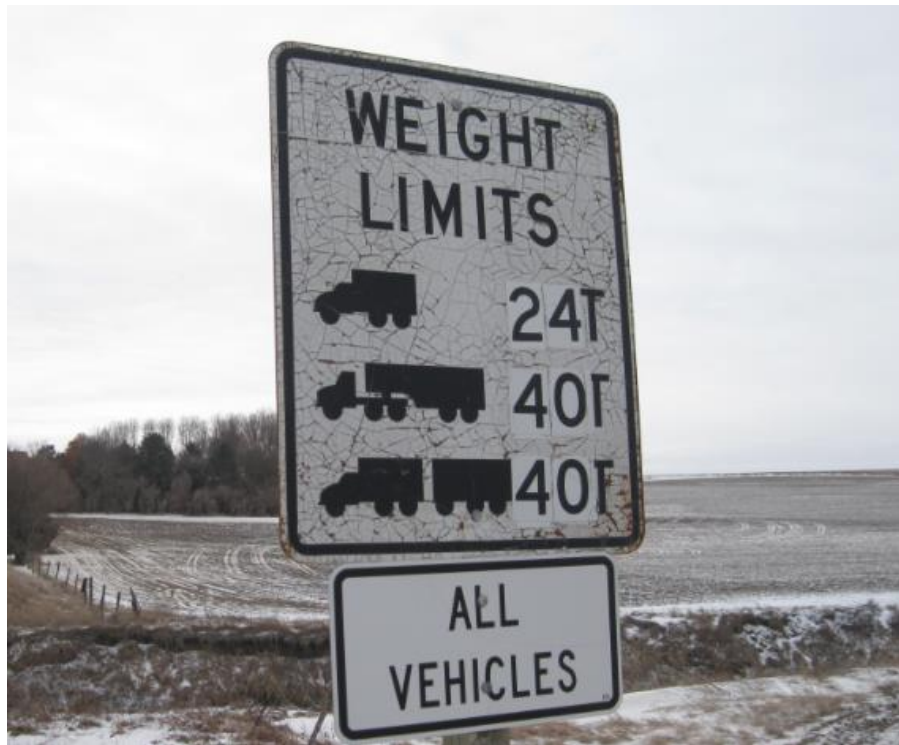
Figure 4. Ida County Bridge load posting

The current load posting for the bridge is shown in Figure 4.

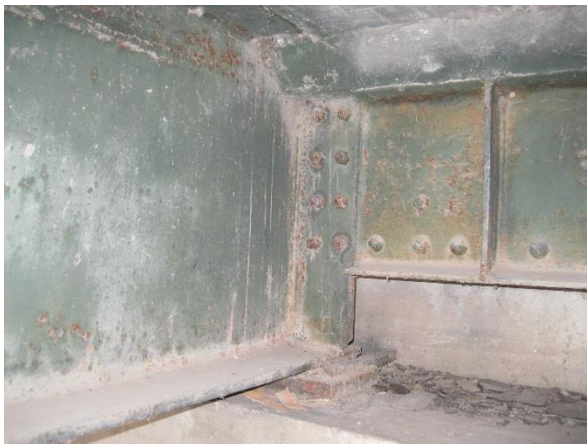
Figure 5. Ida County Bridge bearings

The bridge substructure consists of concrete abutments/backwalls and concrete piers. Seven in. curved plates provide the bearing at the abutments and rockers provide the bearing at each pier as shown in Figure 5.

a. Abutment bearing

b. Pier bearing

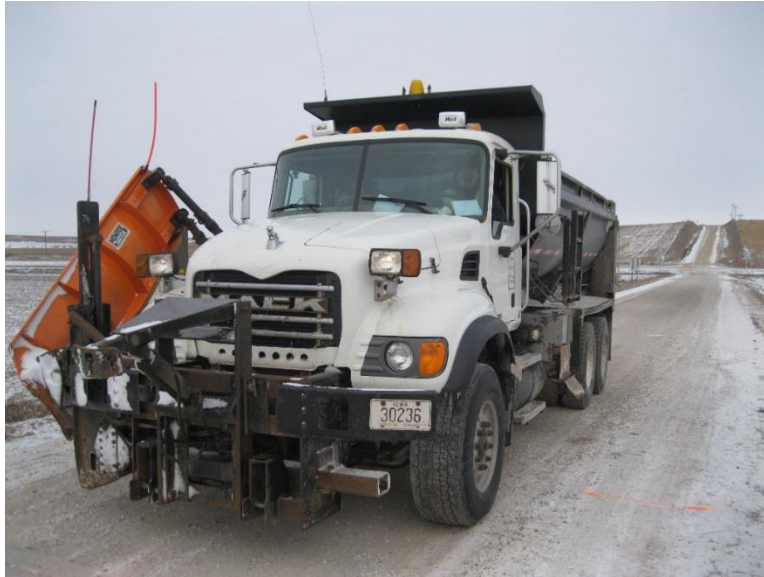
Figure 11. Ida County Bridge test truck

Loading of the structure was completed using a loaded and known tandem axle dump truck provided by Ida County, shown in Figure 11. Figure 12 shows the load truck dimensions and axle weights at the time of testing.

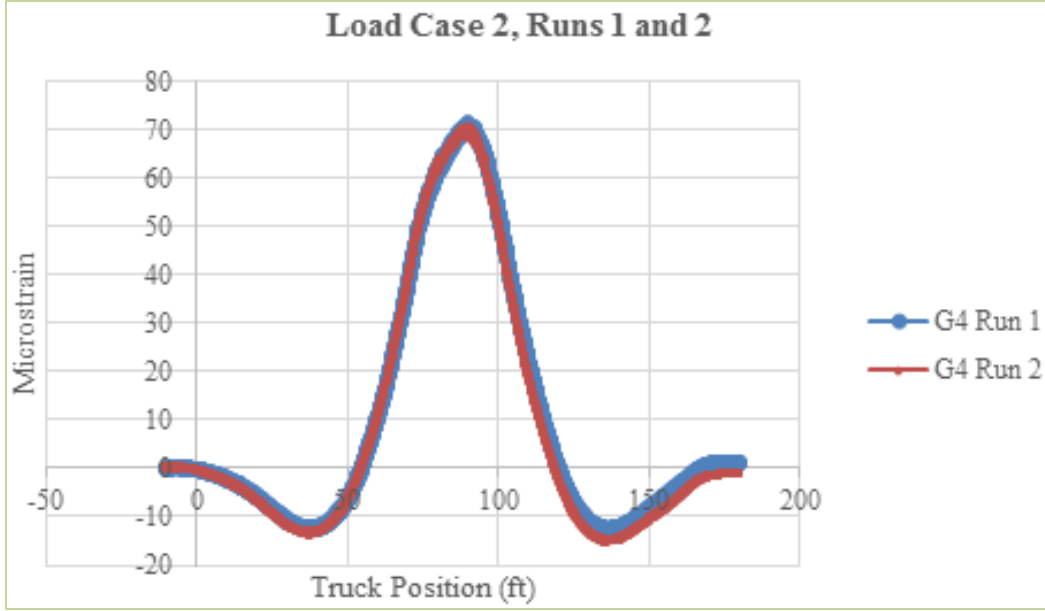
Figure 14. Data reproducibility for Ida County Bridge test

Figure 14 illustrates a strain history plot versus truck position for two tests of Load Case 2 on the bridge.

Comparison of the two data sets in Figure 14 indicates good reproducibility in the data. Returns to approximately zero after passage of the load truck suggests elastic behavior in the response. All load cases had similar response histories with respect to the degree of reproducibility and elastic behavior; therefore, one data set from each load case was selected for further, more in-depth, evaluation.

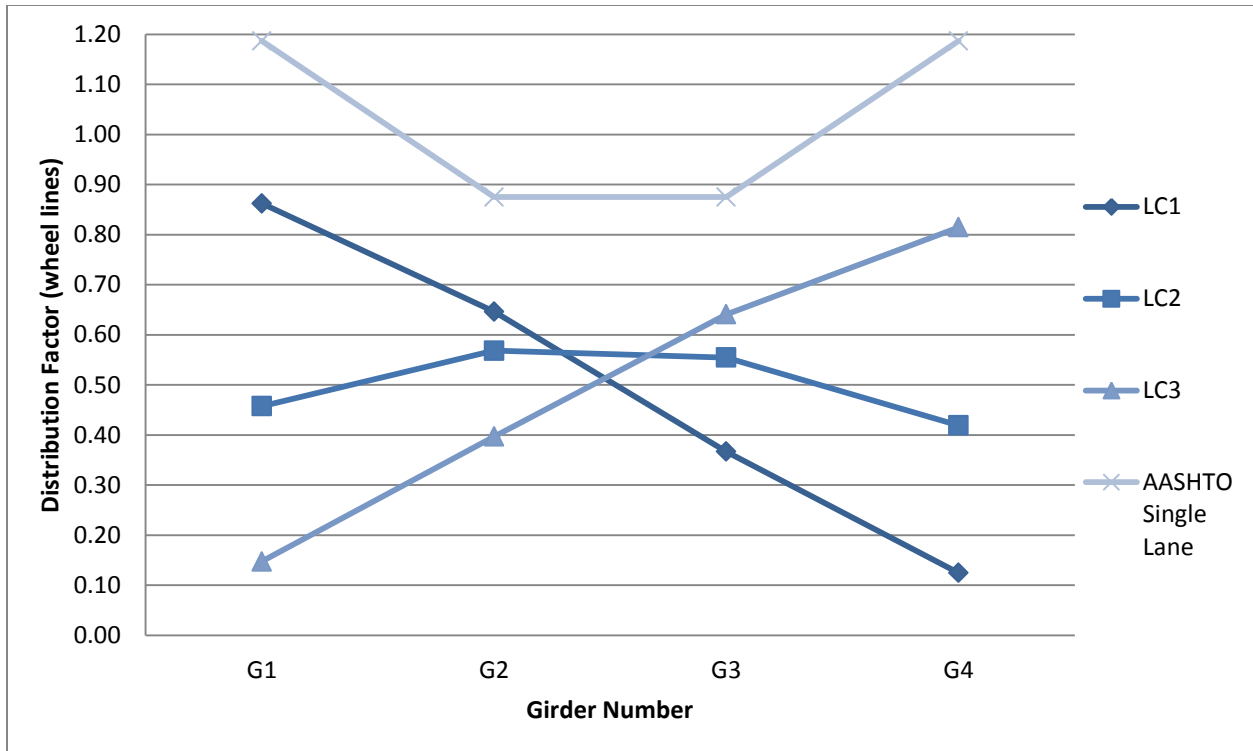
Figure 15. Ida County Bridge center span distribution factors

Approximations of the transverse load distribution characteristics of the structure were obtained using the measured strains from the load tests. Using the measured strains and equation 1, distribution factors (per wheel line) were calculated for each load case at midspan of both the center span and the approach span and are presented in Figure 15 and 16, respectively.

In addition to the calculated distribution factors from the field strains, the American Association of State Highway and Transportation Officials (AASHTO) Standard Specification (1996) load distribution factors are also presented for comparison. In all cases, the field-measured distribution factors are less than those calculated using the code-specified equations.

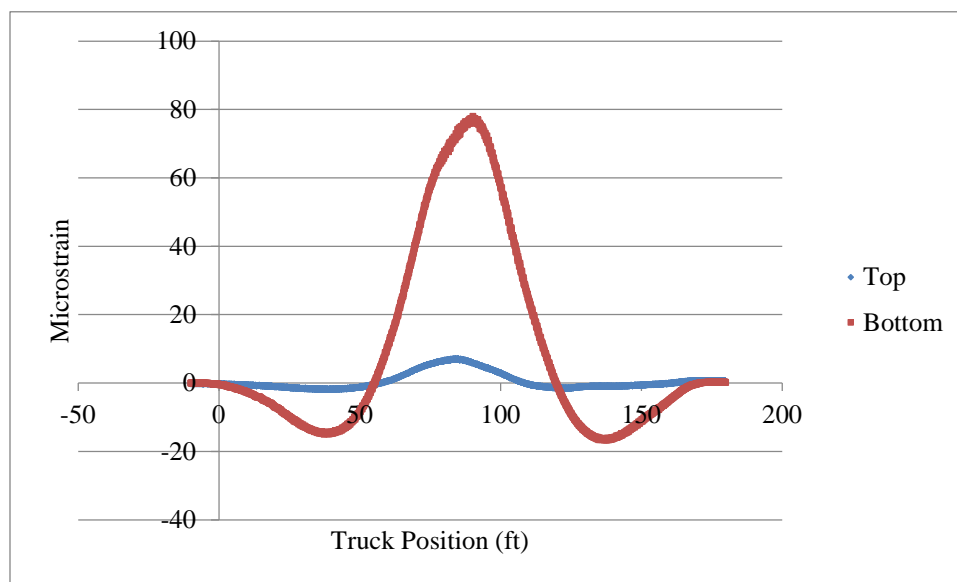
Figure 17. Ida County Bridge top and bottom flange strains on Girder 3 for Load Case 2

Based on the information available from the inspection reports and plan sheets, it was believed that shear connectors were not utilized on the original structure. With that said, evaluation of the top and bottom strain magnitudes for each girder was completed to determine the location of the neutral axis and therefore the presence and degree of any unintended composite action. The field-calculated neutral axis information was then utilized during the model calibration discussed in the next section. Figure 17 illustrates the top and bottom flange strains measured on girder G3 for Load Case 2.

Similar plots were generated for all girders at both midspan cross sections (sections B and D in Figure 8), for evaluation of the neutral axis location at each location. Based on the data illustrated in Figure 17 and similar plots for all girders, it was determined that the Ida County Bridge exhibited some degree of unintended composite action at all girder locations. The exterior two girders, G1 and G4, displayed the least significant amount of composite action.
